DEPARTMENT OF TRANSPORTATION

Quality Assurance and Source Inspection

Contract #: 04-0120F4Cty: SF/ALA Rte: 80 PM: 13.2/13.9File #: 1.28**WELDING INSPECTION REPORT****Resident Engineer:** Casey, William**Address:** 333 Burma Road**City:** Oakland, CA 94607**Report No:** WIR-028836**Date Inspected:** 07-Dec-2012**Project Name:** SAS Superstructure**OSM Arrival Time:** 700**Prime Contractor:** American Bridge/Fluor Enterprises, a JV**OSM Departure Time:** 1730**Contractor:** American Bridge/Fluor Enterprises, a JV**Location:** Jobsite**CWI Name:** Fred Michels**CWI Present:** Yes No**Inspected CWI report:** Yes No N/A**Rod Oven in Use:** Yes No N/A**Electrode to specification:** Yes No N/A**Weld Procedures Followed:** Yes No N/A**Qualified Welders:** Yes No N/A**Verified Joint Fit-up:** Yes No N/A**Approved Drawings:** Yes No N/A**Approved WPS:** Yes No N/A**Delayed / Cancelled:** Yes No N/A**Bridge No:** 34-0006**Component:** OBG 13 and Tower**Summary of Items Observed:**

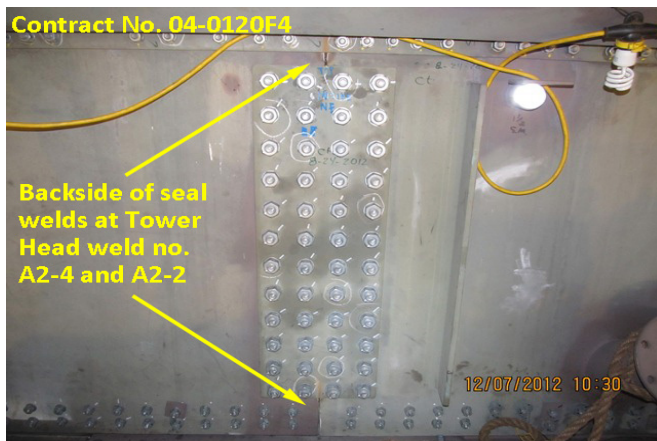
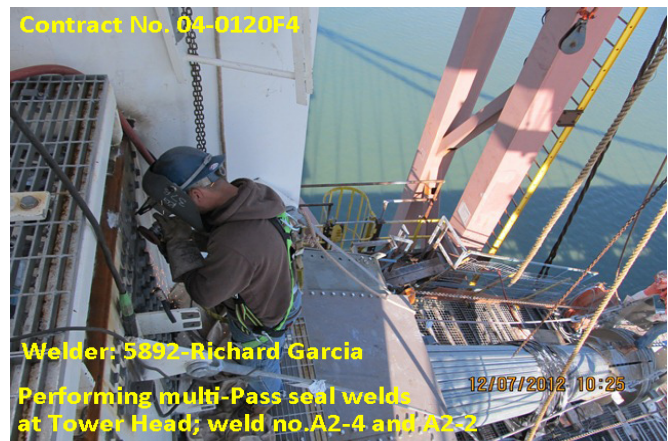
The QAI observed that welder 5892-Richard Garcia, was welding multi-Pass seal welds at Tower Head weld no. A2-4 and A2-2 in the vertical (3G) position. This QAI observed these parameters as defined in Weld Procedure Specification WPS-ABF-WPS-F1200A. The QC inspector Fred Michels verified the joint geometry for these locations and found it to be acceptable, this information was relayed to the QAI. The welder then continued pre-heat throughout the area during welding using a propane type weed burner at 40 degrees Celsius (150 degrees

F) which was verified using a tempilstik and infrared gun by the QC. The welder was using the Shielded Metal Arc Welding (SMAW) electrode E7018 for the Partial Joint Penetration (PJP) weld in the vertical (3G) position with 3.2 mm electrode with 127.3 amps. The welder utilized a power grinder and power wire wheel for the interpass cleaning. The QC inspector for this location was Fred Michels and was observed verifying and documenting the welding parameters for this location, along with overseeing the welding operations. At the time METS observation was performed. No issues were noted by the QAI

The welder was grinding the starts and stops between weld layers to a bright metal. The location was still in process at the end of this QAI's shift
